Installing Wood Posts for Greatest Longevity in Farm or Paddock Fencing

Terry Conners, Extension Specialist for Forest Products, Department of Forestry

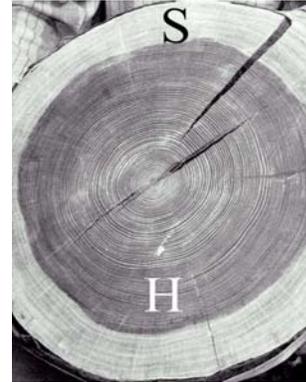
Figure 2. Cross-section of log showing heartwood (H) and sapwood (S).

² Southern pine posts have a thick sapwood layer and very little (if any) heartwood, but red pine posts have a thin sapwood and significant amounts of heartwood.

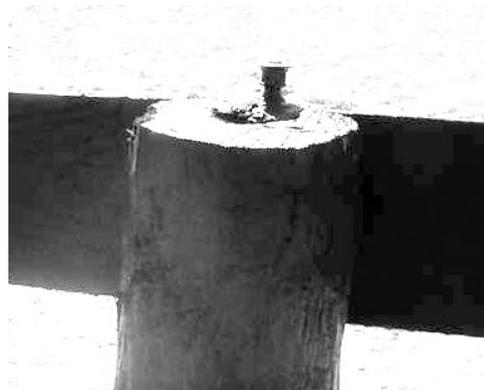
Figure 3. Treated pine post. The sapwood was properly preserved, but the untreated heartwood began to rot underneath the paint. Brush-on remedial preservative treatment would probably have helped this particular post.

Examples of problem installations: If fence posts are painted while they are still wet a potentially expensive-to-correct situation could develop, especially if untreated wood is exposed (e.g., by trimming the upper end during installation). Figures 3 and 4 show two examples of posts with differing degrees of degrade problems. Both of these CCA-treated pine posts were photographed after being in place for only a few years. The posts had the ends cut off, no

remedial wood preservative treatments were applied, and they were both painted soon after installation.

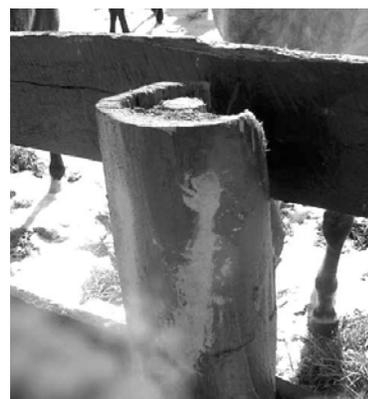
Figure 4. Treated pine post. Untreated wood began to rot, with the sapwood being more significantly affected than the slightly more rot-resistant heartwood. This degree of sapwood degrade would not be expected for properly preserved wood, so this particular post may have had an inadequate preservative treatment. Its poor condition was probably worsened by the lack of after-cutting preservative treatment and by the paint applied soon after installation that trapped water within the post.
